QA Technology Company, Inc.

A p p l i c a t i o n s N o t e
Life Test Performance Comparison
039 mil 8R-S Razor Probe With & Without Riser Block

Document# D10071

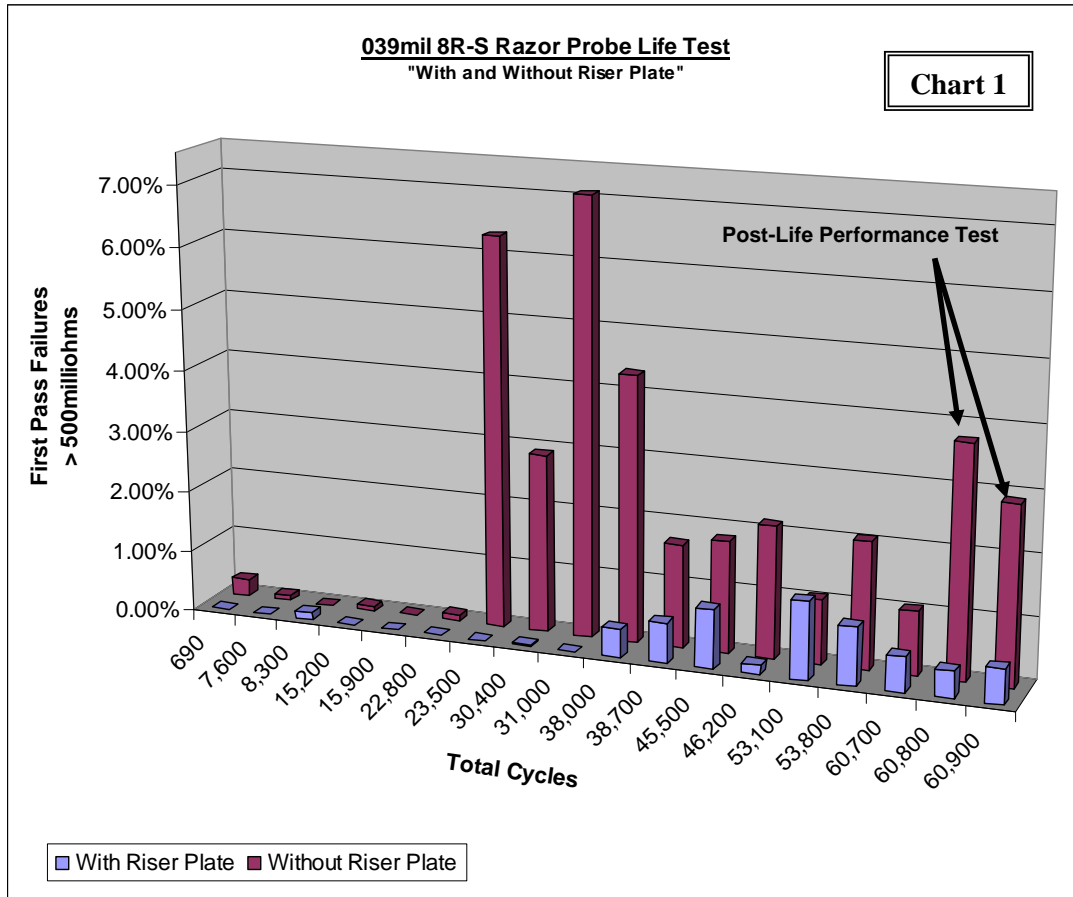
For Life Cycle testing, each probe was cycled 691 times per TV, collecting resistance measurements at each new via location. The same board was then fed through the test apparatus again, cycling each position 10 times before indexing to the next via, where a resistance measurement was taken, continuing until each probe cycled about 6,900 times per TV. A new TV was then inserted and using the same probes, the entire procedure was repeated until completing about 60,000 cycles per probe. After completing 60,000 cycles in the Life Test the probes were used again in a Post Life Performance Test for both board types. For Performance testing, each TV via was hit (cycled) one time per probe, taking a resistance measurement, then indexing to a new position and cycling again, taking a new resistance measurement each time. Each probe was cycled thru 100 individual via's to the 691 maximum allowed per TV. Due to via size restrictions inherent to the TVs, each test consisted of only 16 probes, using TV traces 17 thru 32 only.

In Life Testing **with a riser plate (Photo 1)** probe performance was significantly better than without a riser plate, in both the life testing and post-life performance testing with % failures below 1% (**Chart 1-Table 1**).

In Life Testing **without a riser plate (Photo 2)** for the first 6 of the 16 tests, the probes performed well; until test 2401, where the overall performance degraded, with a marked increase of contact failures (**Chart 1-Table 2**). Most failures were attributed to the tip simply missing the via target - hitting off center into the flux filled valley at the edge of the via. For many of the TVs used in the Life Testing, solder paste quality was very poor with an excessive number of vias looking like raised domes (**Photo 3**) of solder instead of vias. Some probes, after striking these raised domes would be permanently biased off center, causing the probe to miss subsequent targets. The problem was probably exacerbated by the fragile nature of the 039mil probe and socket assembly coupled with a 270mil set height needed for this particular vacuum test setup. Upon a random inspection of targets, wherever the probe actually hit a via having good quality solder paste (**Photo 4**), resistance was acceptable. Clearly, a riser plate is needed.

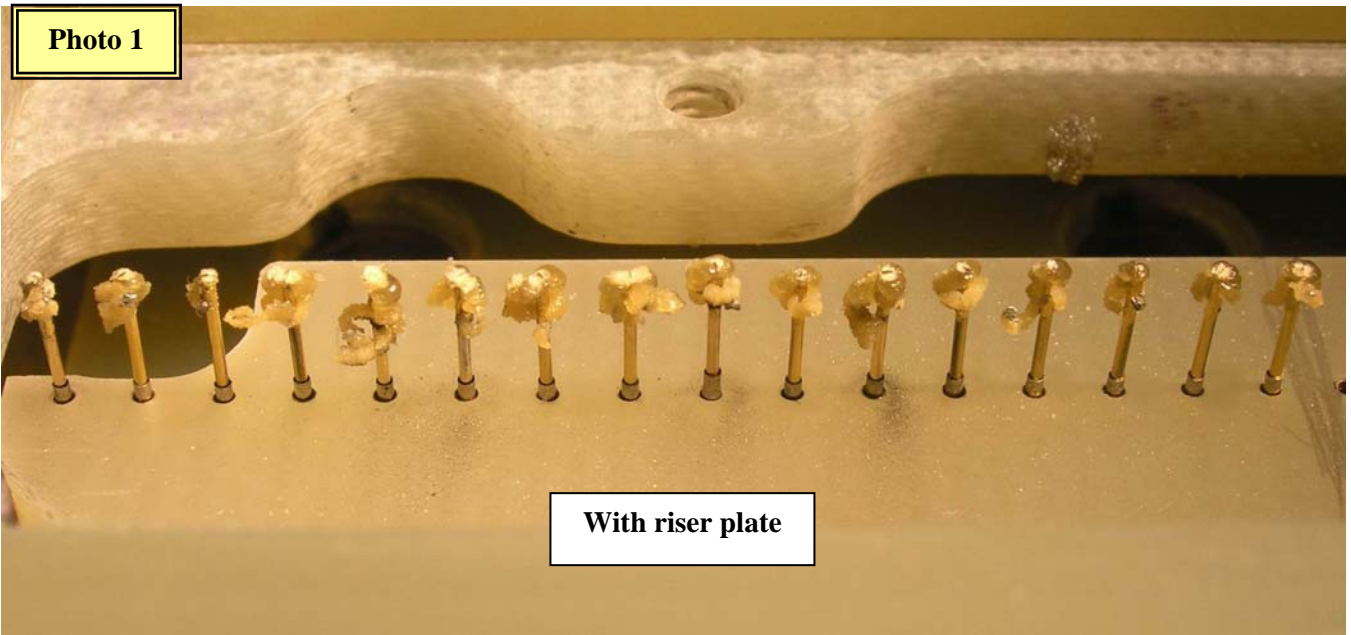
039-PRP168RX-S probes, Post Life Test, after 60,000 plus cycles

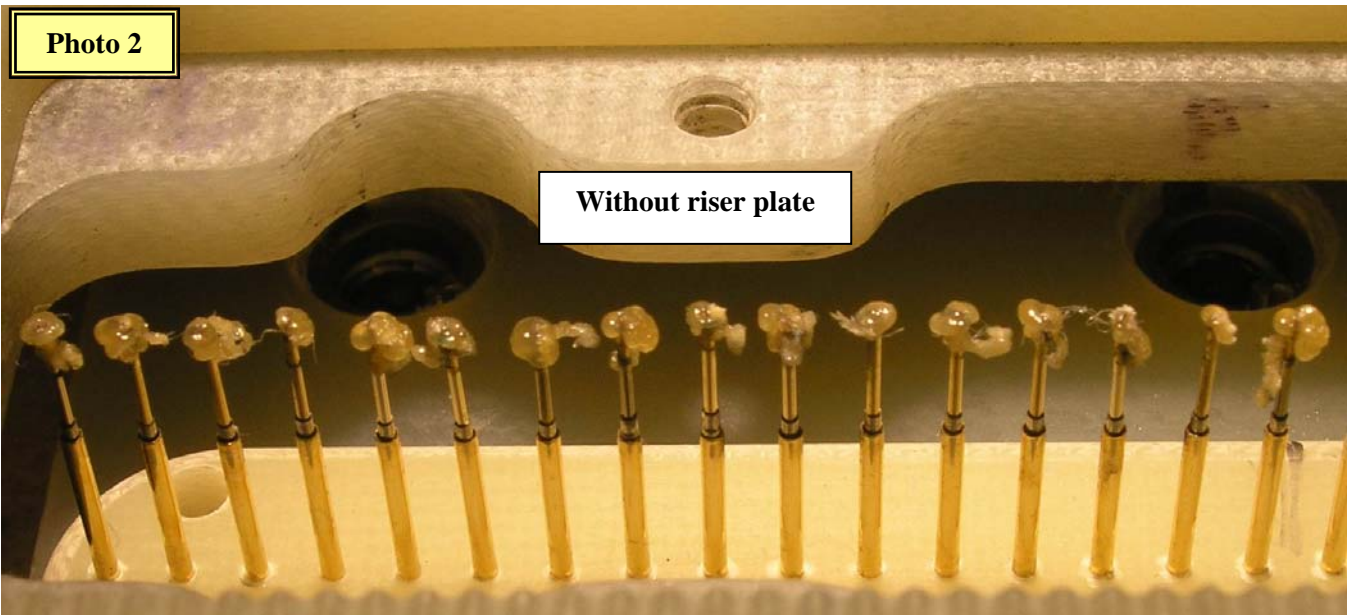
039-PRP168RX-S probes, Post Life Test, after 60,000 plus cycles
